LAKE ELLIS DAM
MA 00005

PHASE I INSPECTION REPORT
NATIONAL DAM INSPECTION PROGRAM

APRIL 1981

Identification Number:	MA 00005
Name of Dam:	Lake Ellis Dam
Town:	Athol
County and State:	Worcester County, Massachusetts
Stream:	Mill Brook
Date of Inspection:	December 4, 1980

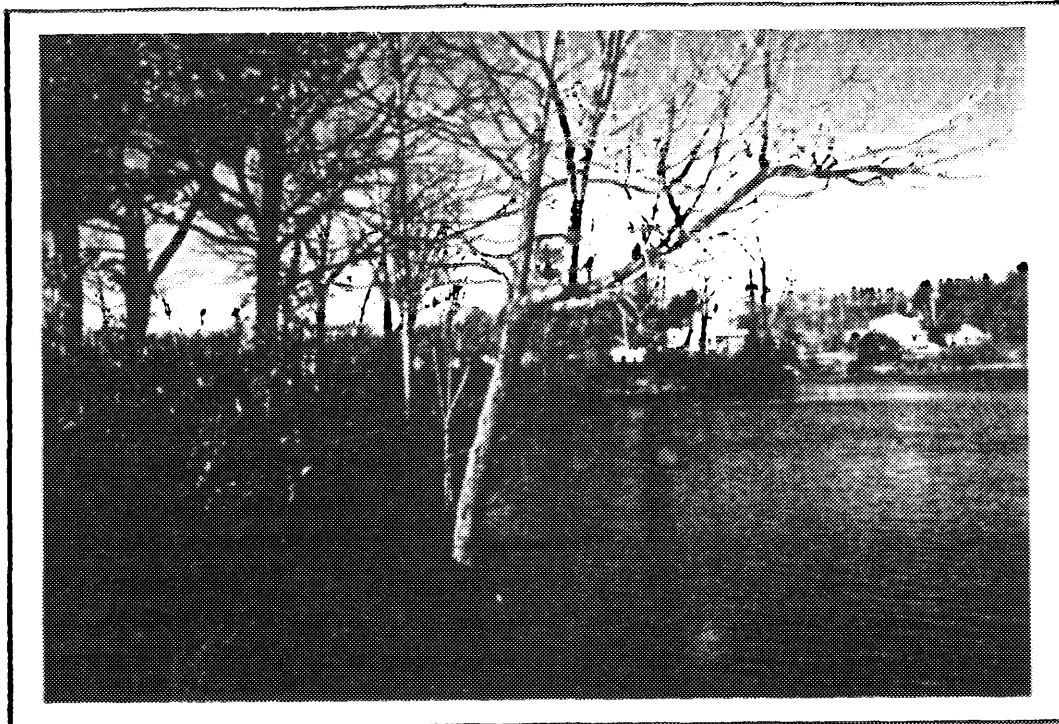
UPSTREAM OVERVIEW OF THE DAM FROM THE SOUTH ABUTMENT.

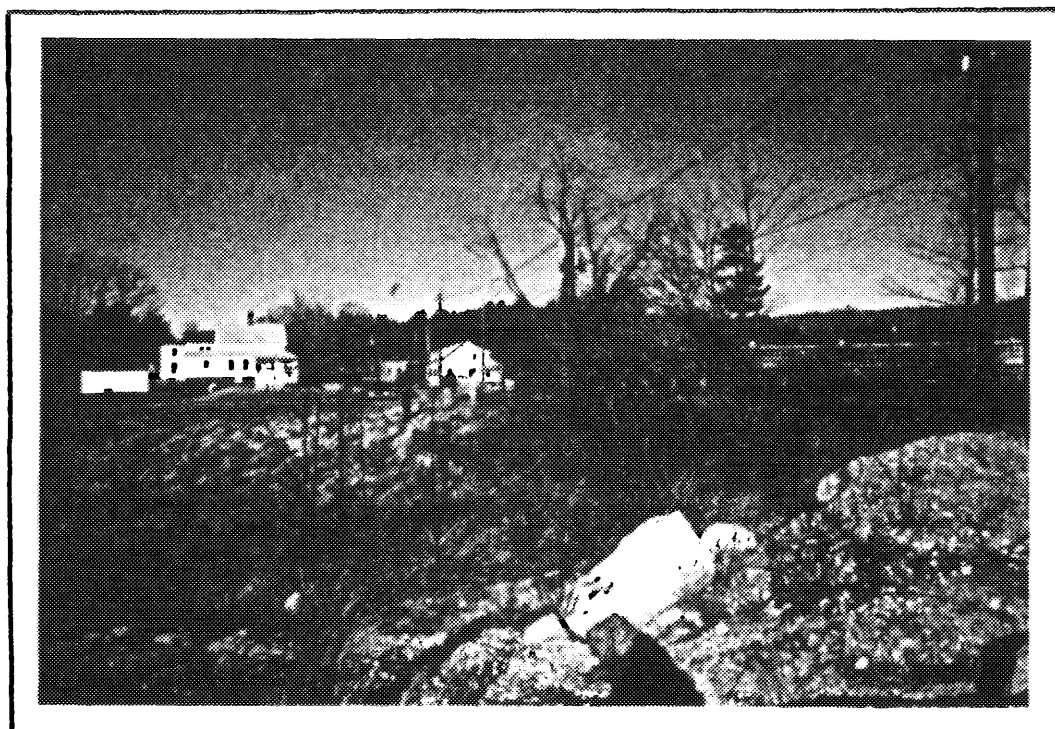
DOWNSTREAM OVERVIEW OF THE DAM FROM THE SOUTH ABUTMENT.

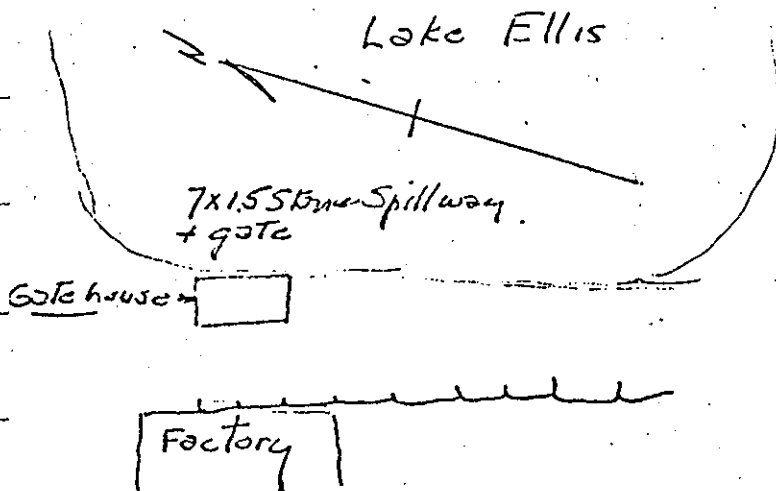
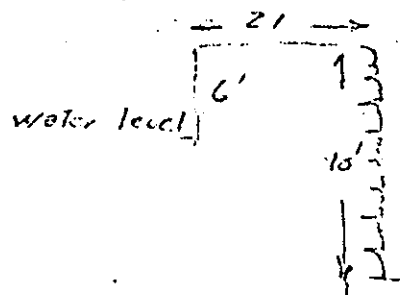
Sketch (Not to Scale):

Earth filled stone faced on down stream side
Gate house (locked) maintenance man says gates probably
don't work

Small leaks noted. Trees + brush on dam should be cut.
Water level maintained 3' ± below small spillway. Only outlet
presently used goes through pipe in boiler room probably
brokenDate 1-4-72By Eaton & Cony Comment _____Dam No. 3-14-15-13

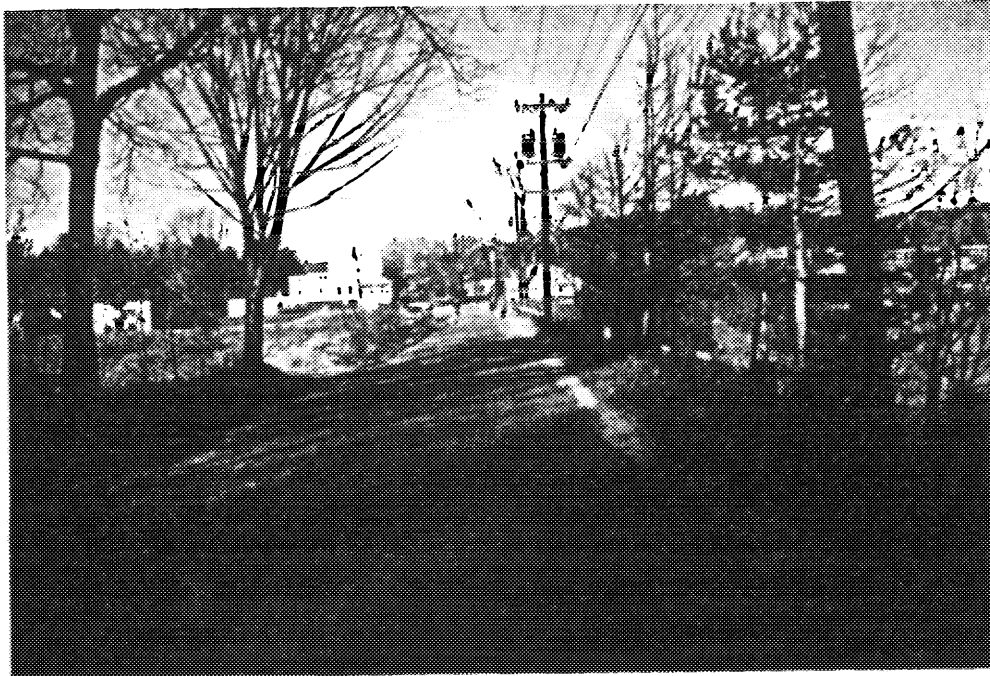
1. VIEW ALONG THE CREST OF THE DAM FROM THE SOUTH ABUTMENT. (12/4/80)

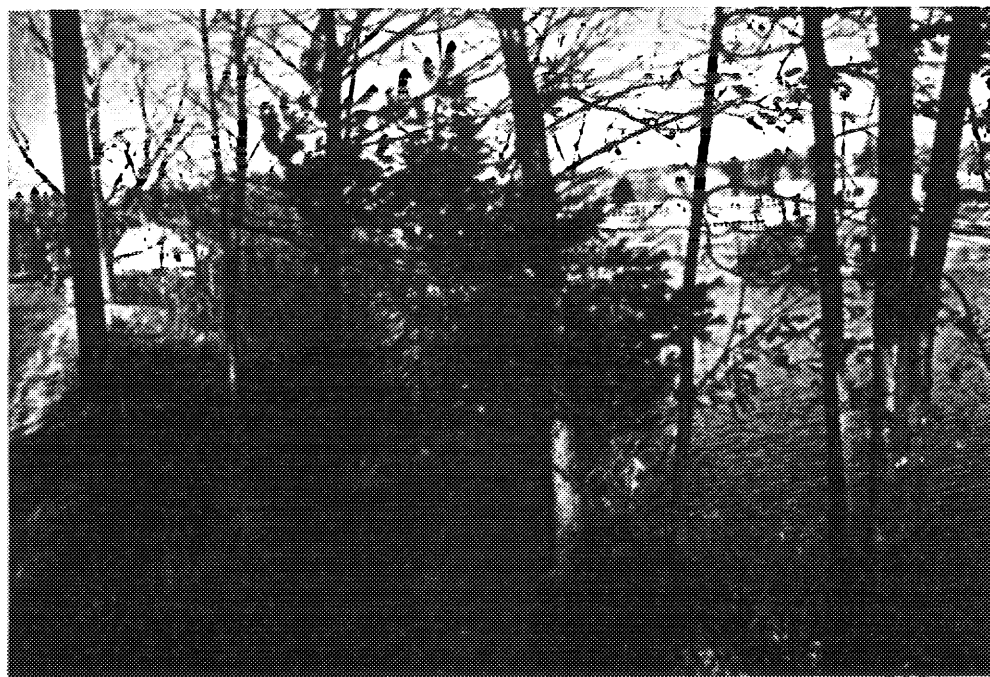
Lake Ellis Dam is an earth embankment about 140 feet long with a maximum height of about 11 feet. Water Street, a hard surfaced road, traverses the crest of the dam which is approximately 20 feet wide. Both the upstream and downstream slopes of the embankment are about 1.5H:1V with trees and brush covering most of the surface. The masonry overflow spillway, which has been blocked off since 1948, never experienced discharge in its 59 year history. All discharges in excess of normal flow from Lake Ellis are directed into South Brook on the south side of the watershed. The Massachusetts Route 2 embankment acts as the dam for the watershed where it crosses the marsh leading to South Brook.

2. UPSTREAM FACE OF THE DAM SHOWING TREE AND BRUSH COVER. (12/4/80)

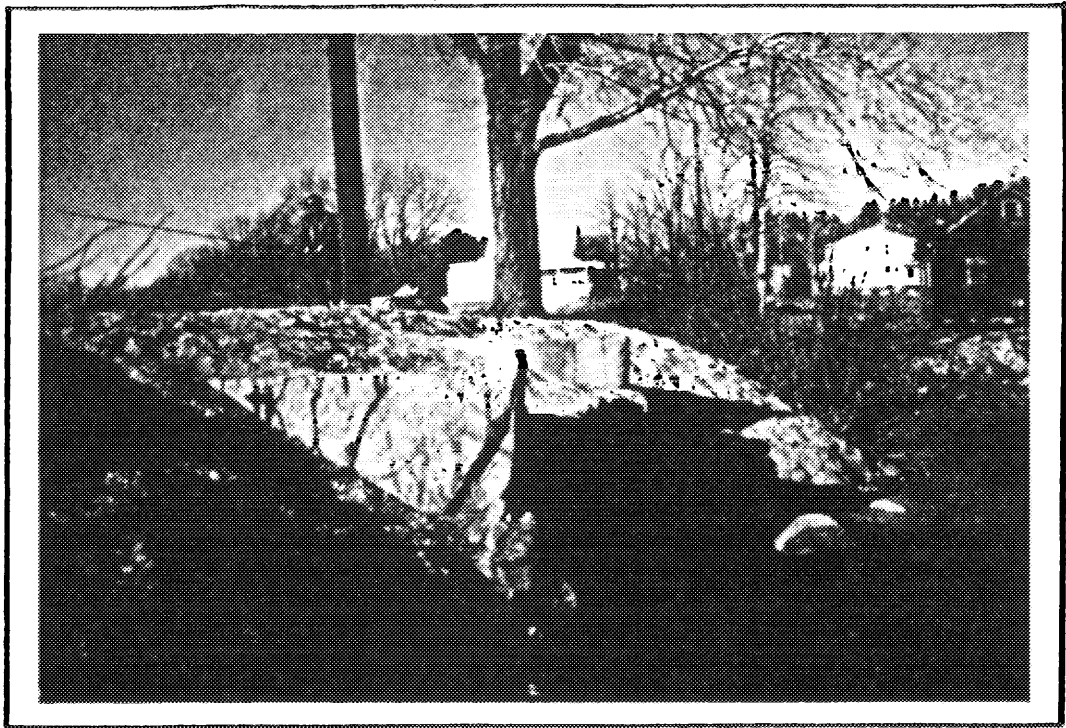
3. INLET TO SPILLWAY WHICH HAS BEEN BLOCKED OFF. (12/4/80)

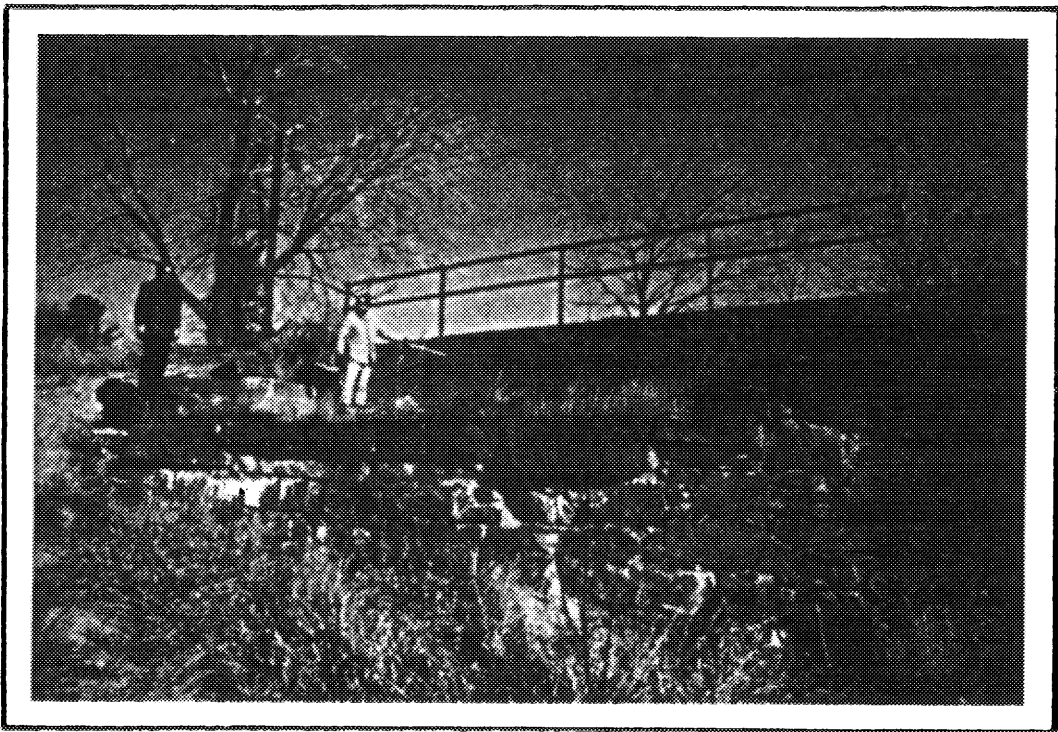
4. DOWNSTREAM SIDE OF THE SPILLWAY WHICH HAS BEEN BLOCKED OFF. (12/4/80)

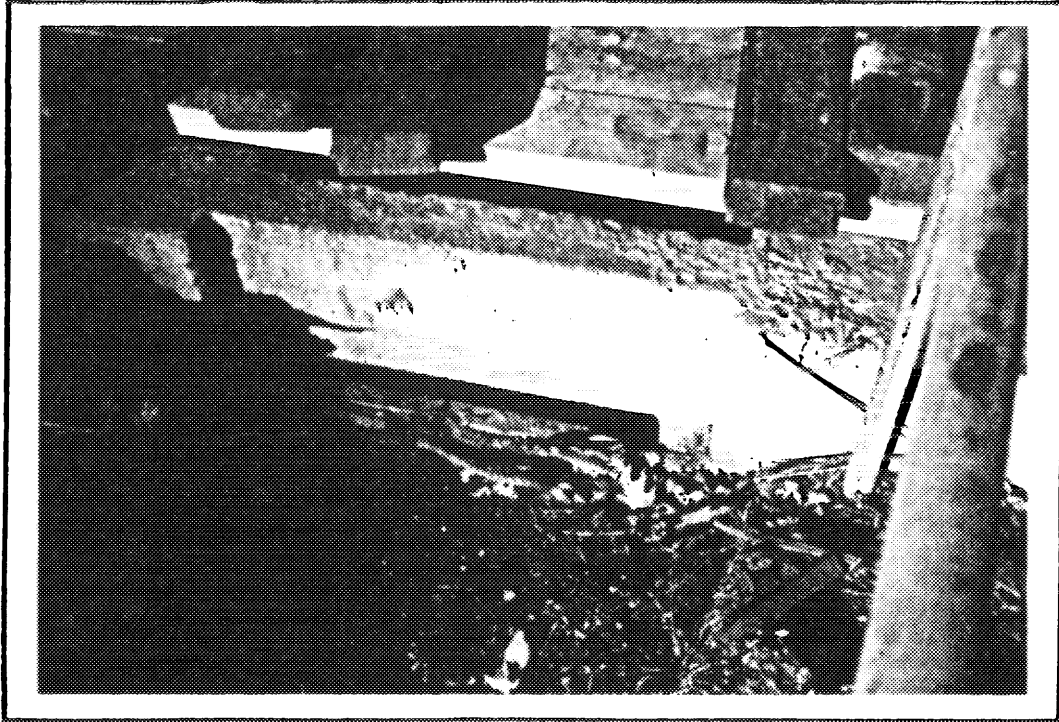
5. RECENT CONSTRUCTION IN THE VICINITY OF THE GATEHOUSE.
(12/4/80)

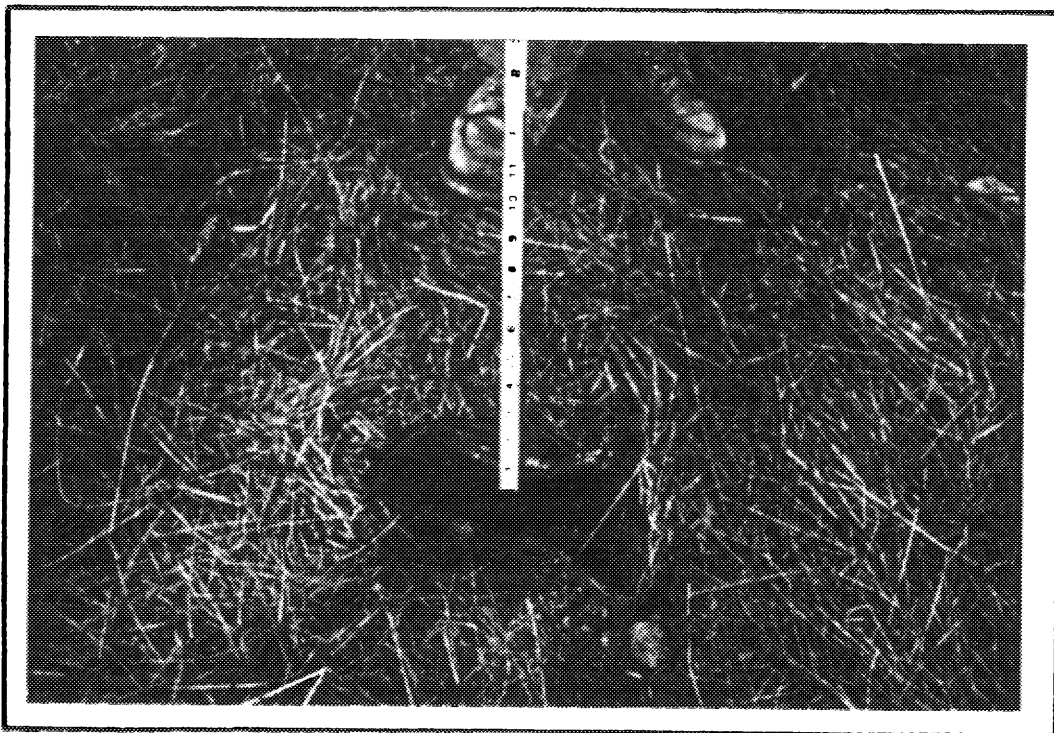
6. CONDUIT FOR VALVE STEM NEAR GATEHOUSE. (12/4/80)

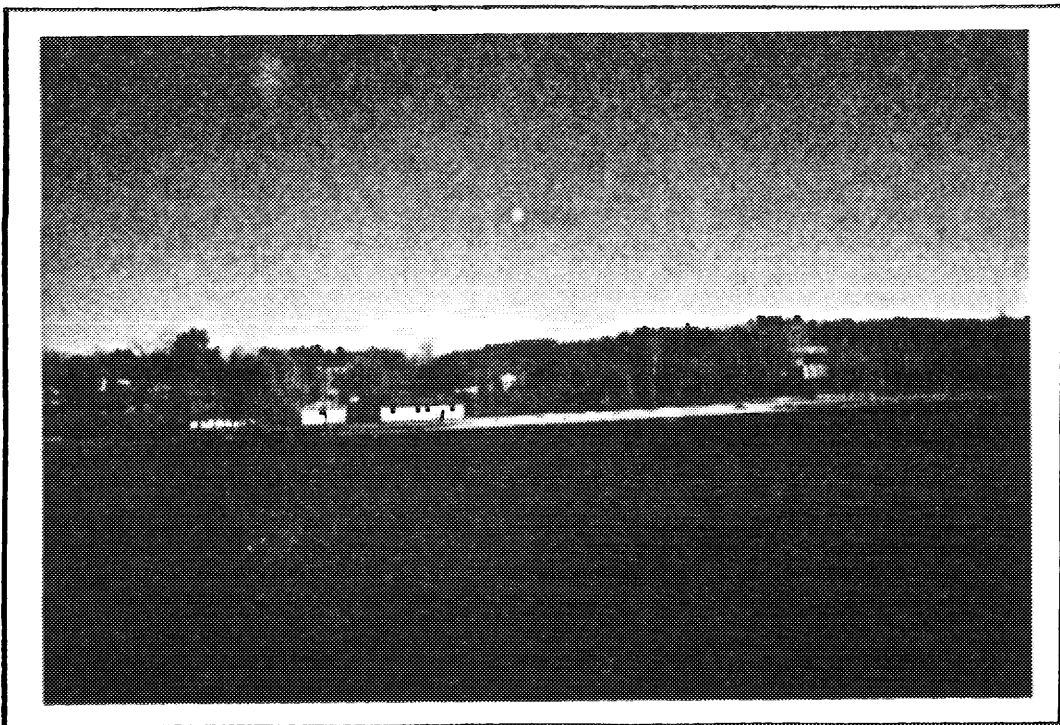
7. OVERVIEW OF ELLIS LAKE AS SEEN FROM THE DAM. (12/4/80)

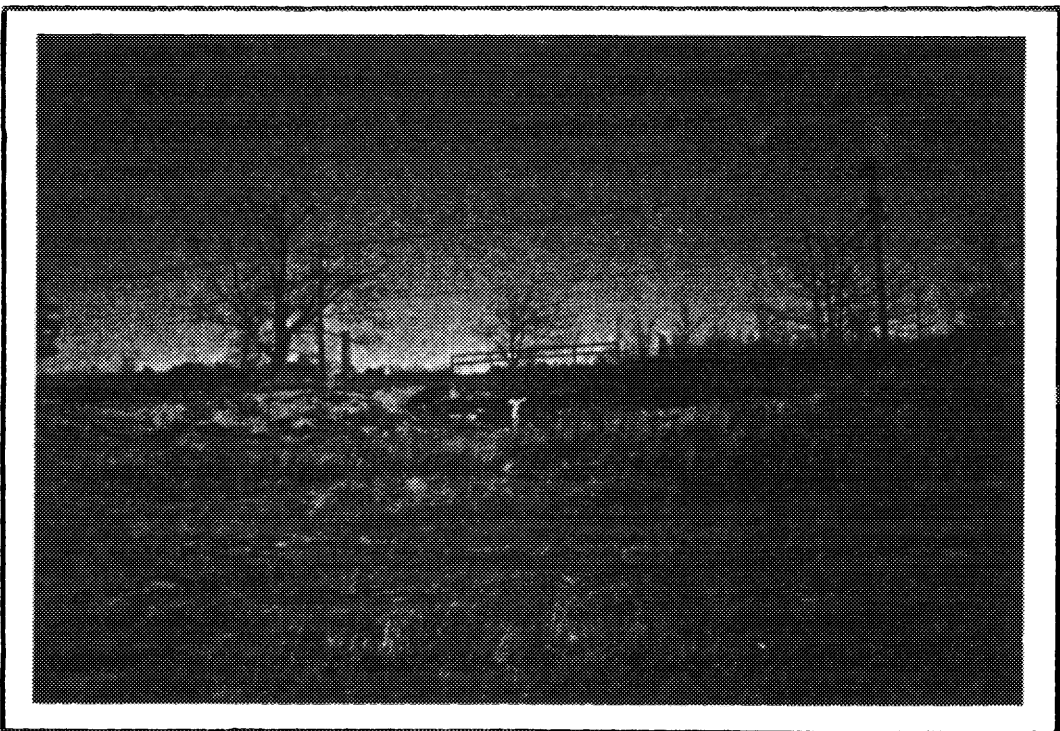
8. FORMER OUTLET CHANNEL OF THE FORMER SPILLWAY. (12/4/80)

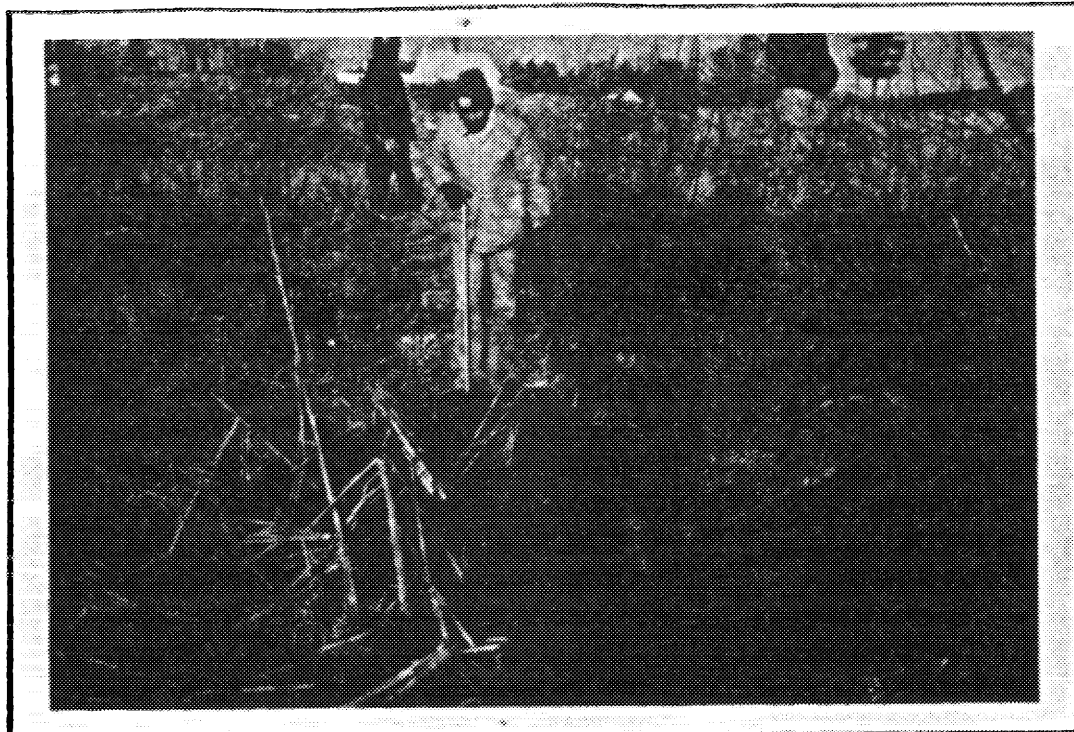
9. OUTLET OF 27-INCH METAL PIPE ABOUT 300 FEET DOWNSTREAM OF THE DAM. (12/4/80)

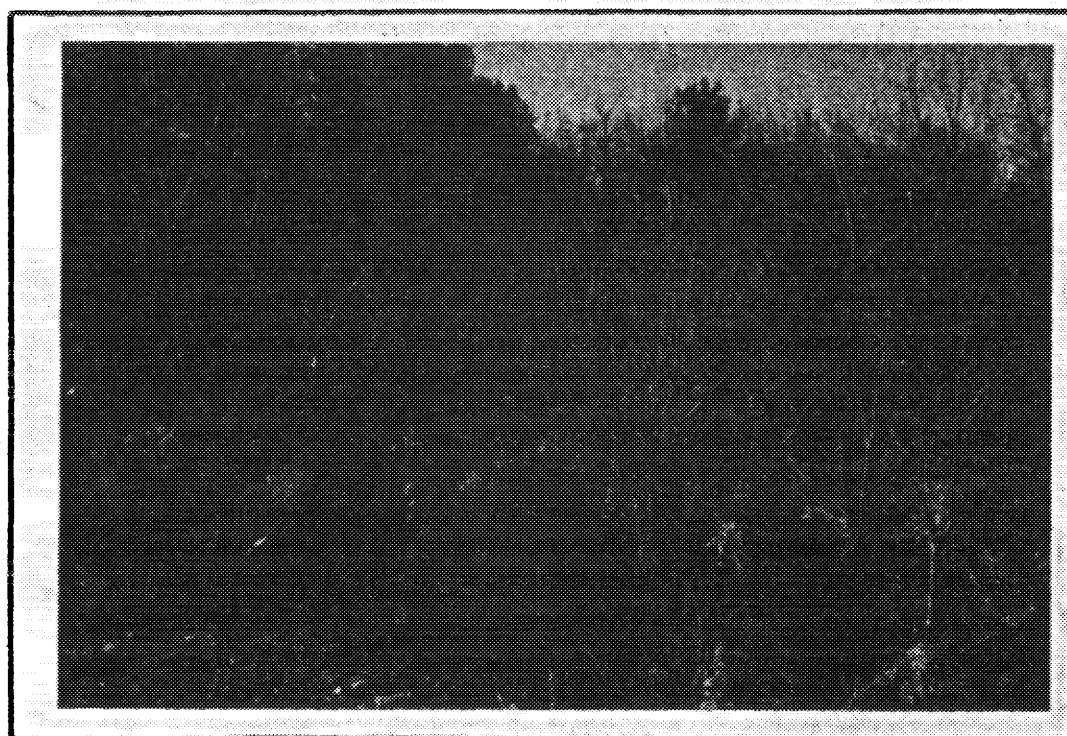
10. TYPICAL CHANNEL CONDITIONS DOWNSTREAM OF THE 27-INCH METAL PIPE OUTLET.
